Pacific Horizon Preserve OCTA Restoration Efforts Map

PACIFIC HORIZON PRESERVE
Disturbed Lands Restoration Map

OCTA Pacific Horizon Preserve Restoration Work Photos

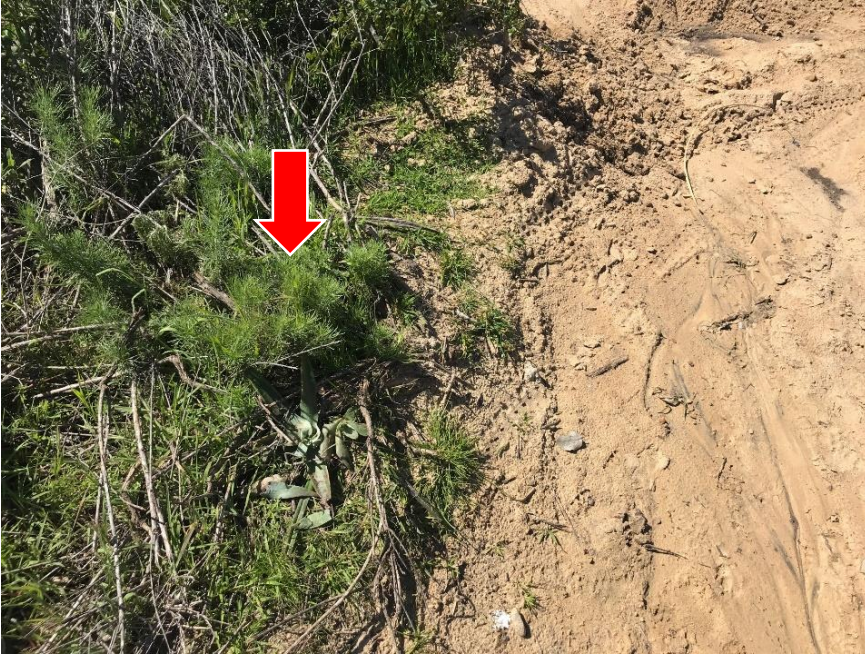
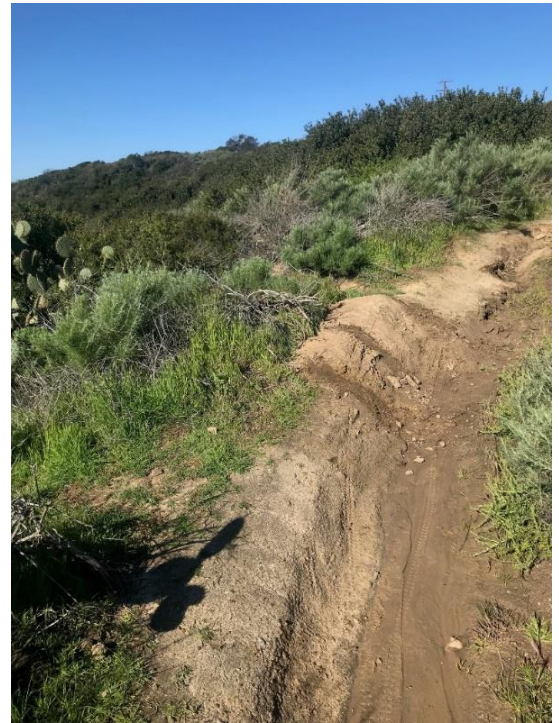
Dudleya crushed by mountain biking activity (above). Dirt berm built by mountain bikers (right).

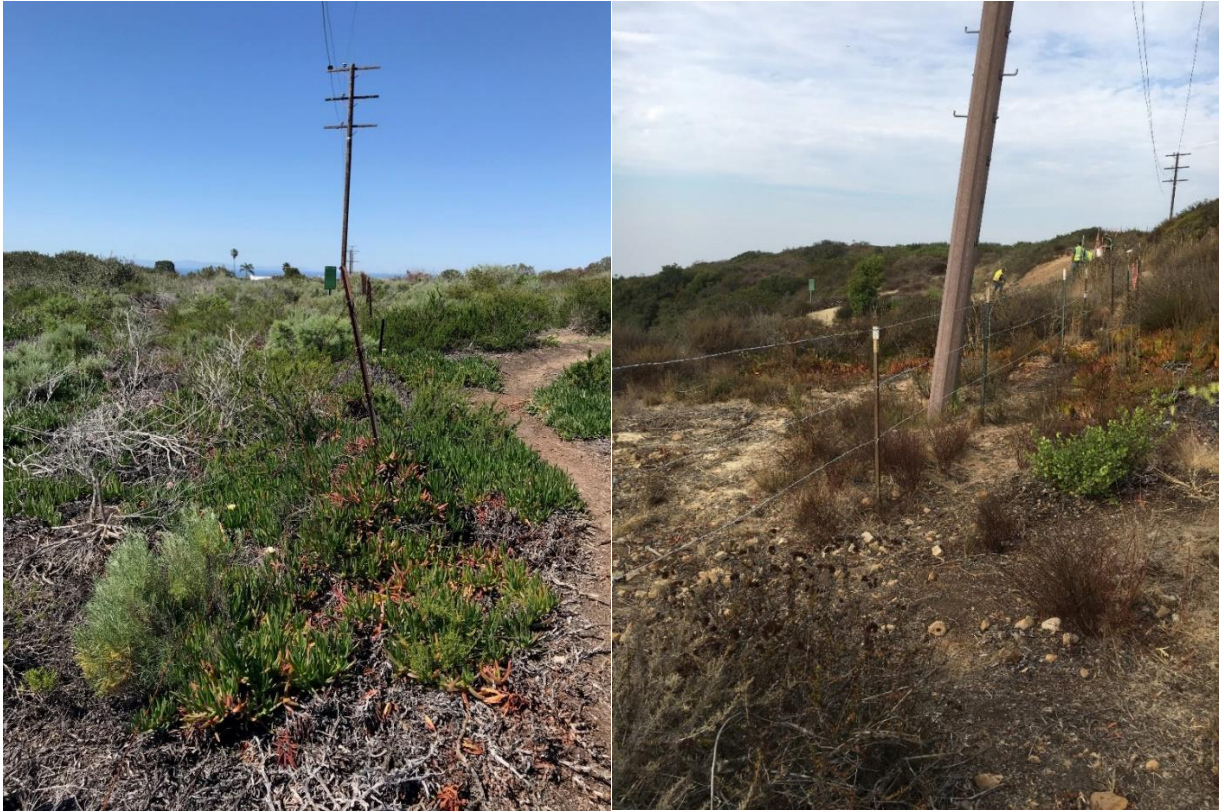
(Left) Old rusty barbed wire fence line. (Right) New smooth wire fence line (wildlife friendly). Contractor was able to utilize some of the same posts. Fence is in the same location.

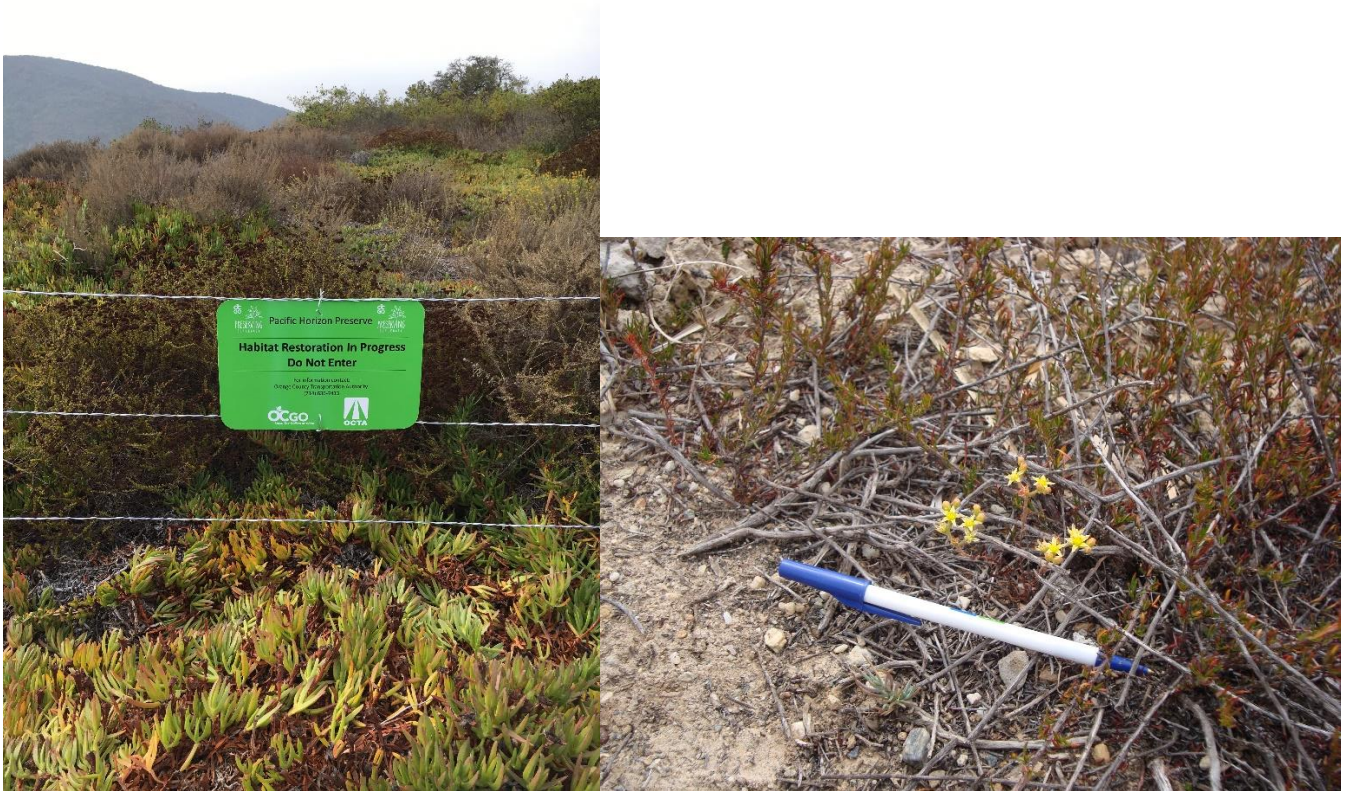
New signage and wildlife camera posts installed. Photo on right (photo from 2015) shows the Many-stemmed dudleya on site that we are trying to protect.

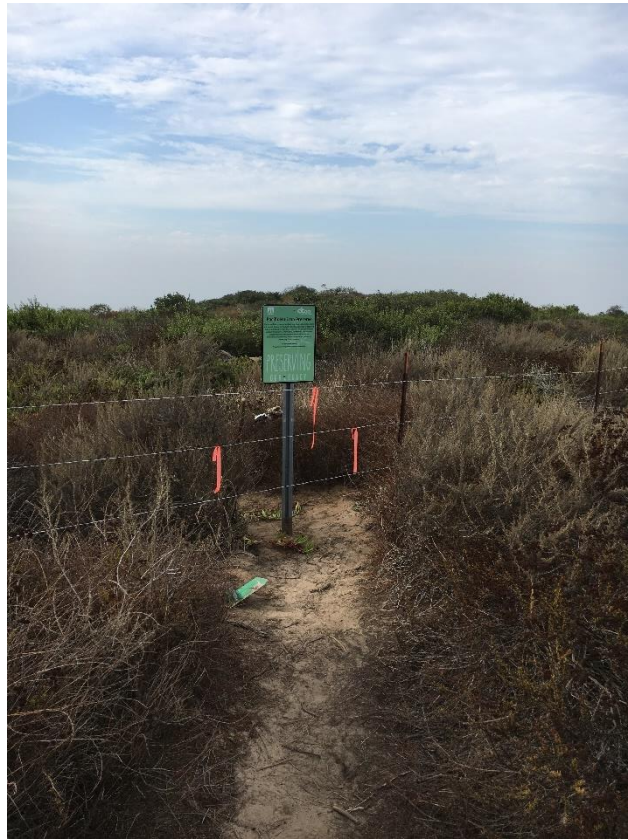
This picture depicts the main access point onto the decommissioned trail. Fence line has been fixed and signage placed.

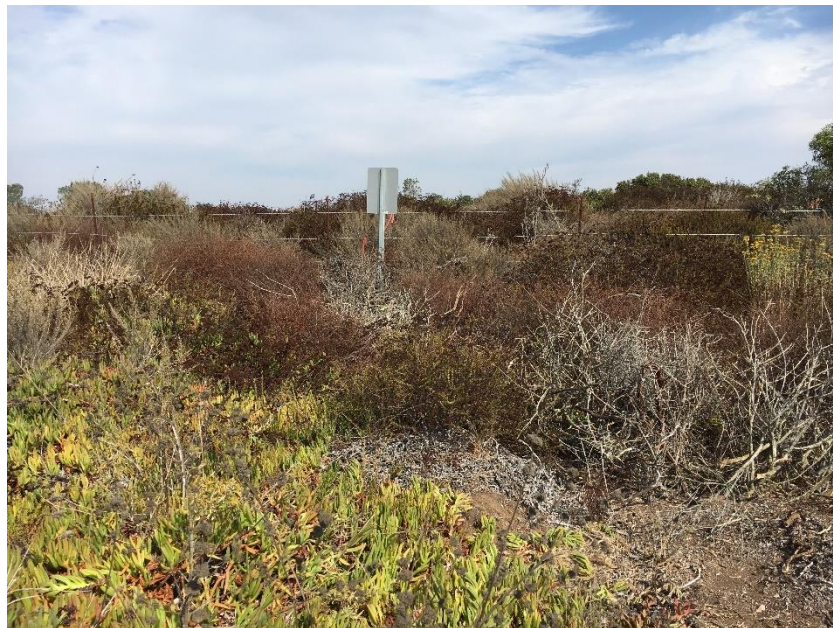
Photo of same entry point looking at the back of the sign. Trail has been obscured with dead vegetation.
