OCTA Environmental Oversight Committee

Item 6 - Trabuco Rose Gully Project Update

Gully Restoration Project Overview

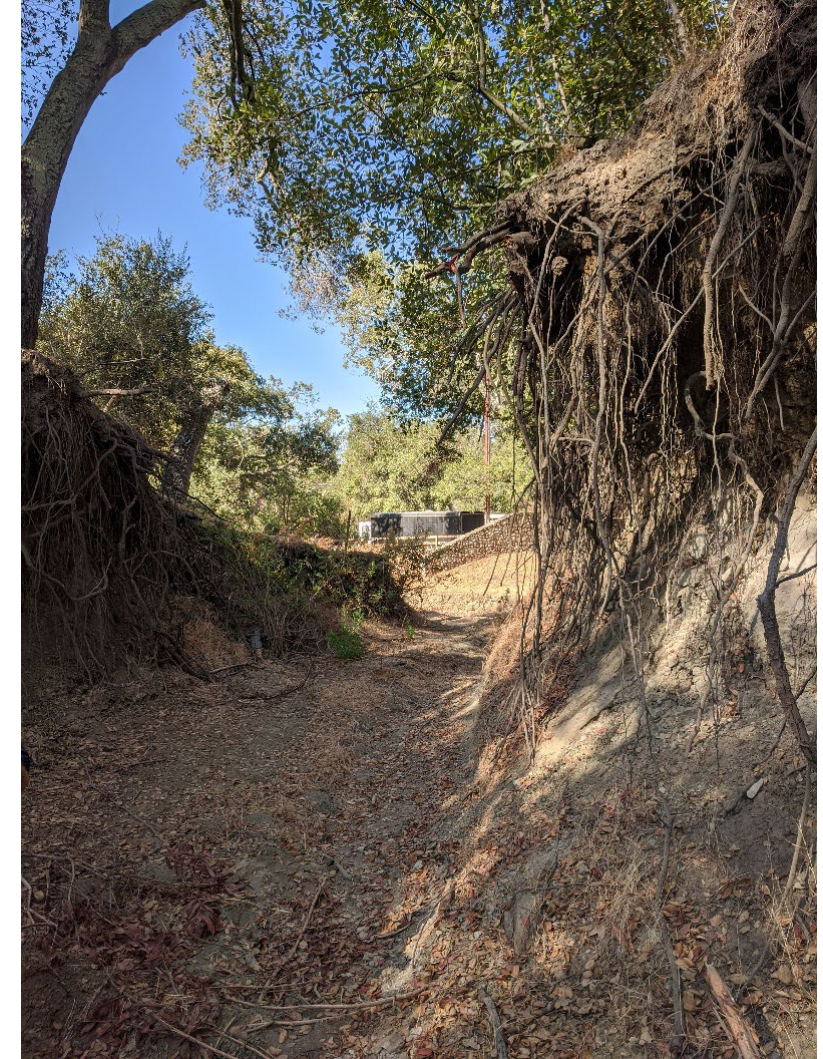
Drainage created artificially decades ago at the Trabuco Rose Preserve. Approximately 150 feet in length.

Undercutting the adjacent oak woodland habitat and compromising the existing infrastructure.

Fill the gully with clean material to create a more natural like creek system.

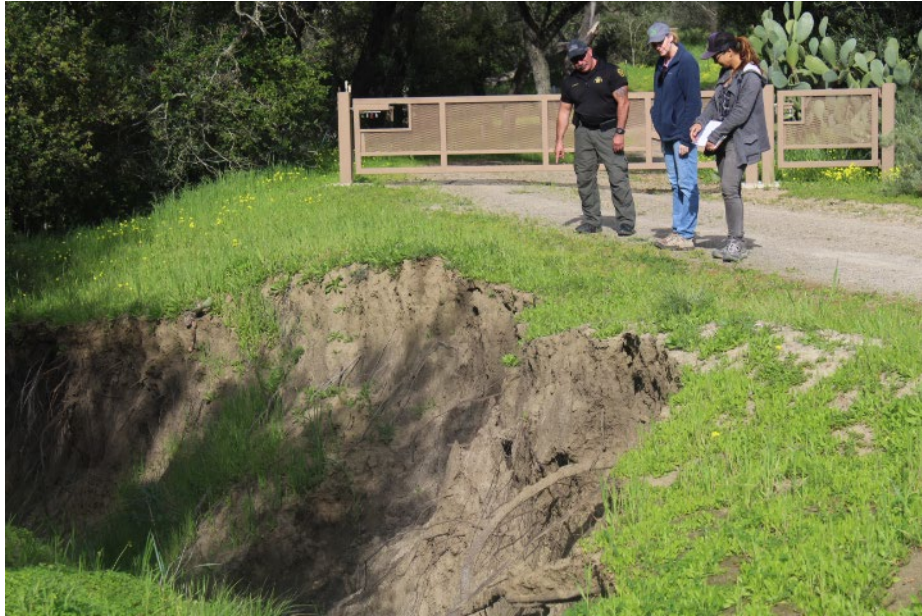
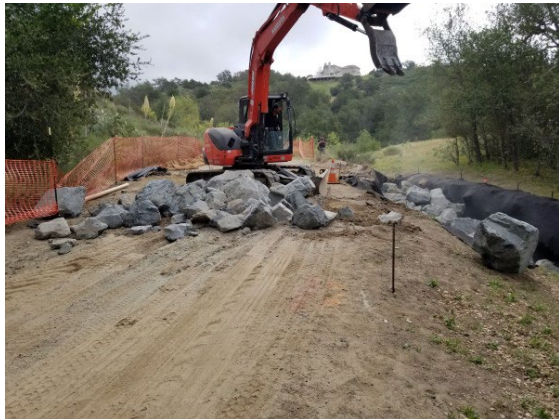
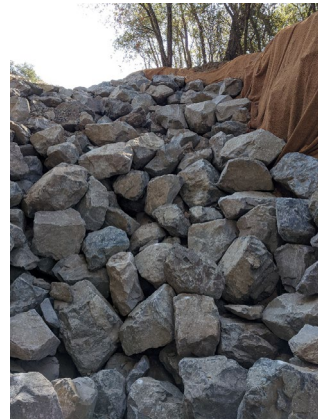
Phase 1 of the Gully Project

Stabilization of the upstream portion (approximately 80 linear feet).

Geotech fabric, jute netting and rock were all used to help armor the creek and halt slope failure and sedimentation.

Design, agency coordination and stabilization of the downstream portion of the gully.
